Removing and installing/replacing cover on front door handle (passenger side) (3 PJ)

51 41 017 | REP-REP-RAE9051-5141017 - V.3

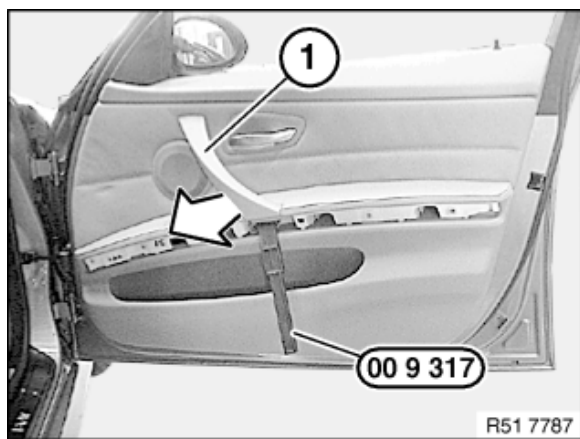
Lever out cover (1) with special tool 00 9 317.

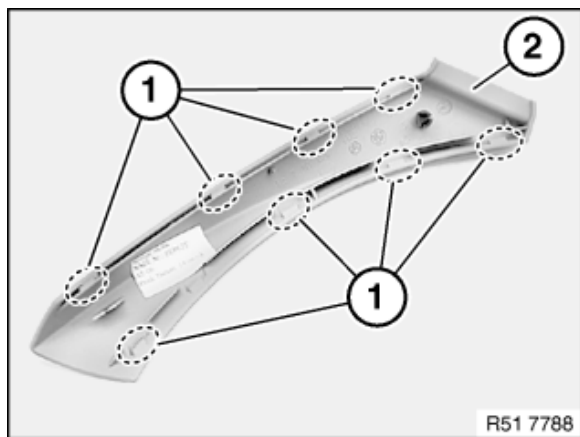
Catches (1) of cover (2) must not be damaged.
